AMA 8

Three trenches, 801, 802 and 803 are expected to define the exact location and state of preservation of the Derby Silk Mill leat. Previous excavations have identified small segments of this feature, but a comprehensive view has never quite been achieved. Trenches 801 and 802 are complete, with Trench 803 to commence upon receipt of relevant permissions.

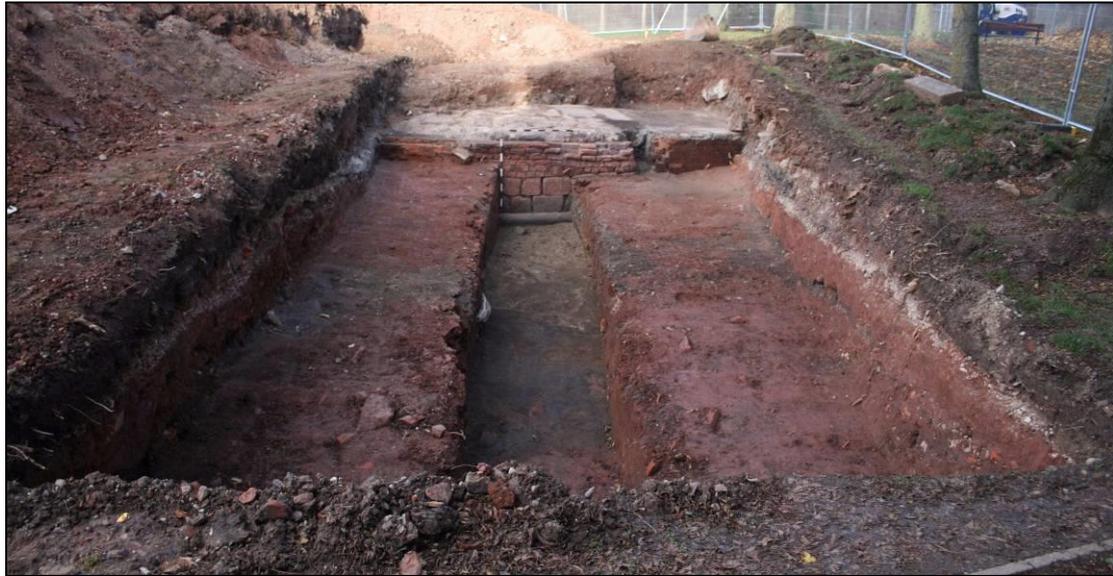
Figure 1. Photograph of Trench 1 looking north

The excavation of Trench 801 successfully identified the northern extent of the Silk Mill leat 1m below the modern ground surface (figure 1). The uppermost southern extent of the leat (not the basal channel) was not revealed and is expected to either exist beyond the southern limit of the trench.

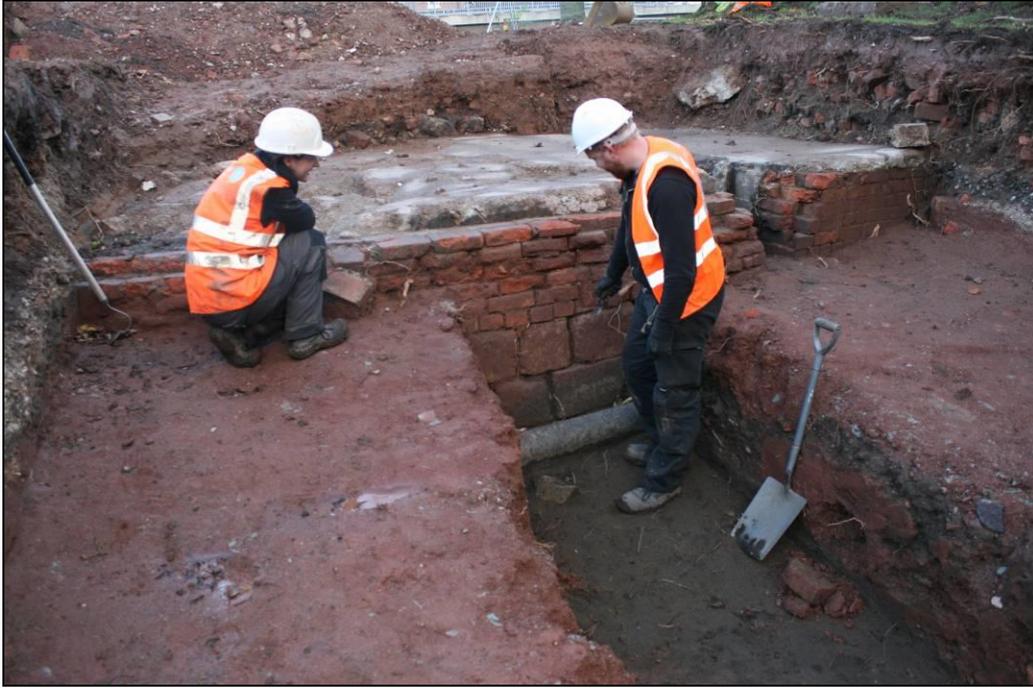
Figure 2. The mill leat wall

The wall which lined the edge of the leat was constructed from brick and sandstone blocks. The brick portion was three courses thick and six courses high and was bonded with a mortar. Beneath the brick course were roughly hewn sandstone stone blocks which measured approximately 380mm x 200mm (figure 2). Given that the excavation had to cease at 1.7m as a consequence of the maximum zone of impact, a hand auger was used to assess the depth of the leat and to glean a more in depth knowledge about the sequence of deposits. The bore hole was positioned in the centre of the lower tier trench and reached a depth of 1.3m (which equates to 44.613m AOD) where the auger reached solid material which is presumed to be the base. The top of the leat wall was recorded at 47.133m AOD indicating that the leat measured approximately 2.52m in depth (not accounting for any truncation which may have occurred to the wall post abandonment).

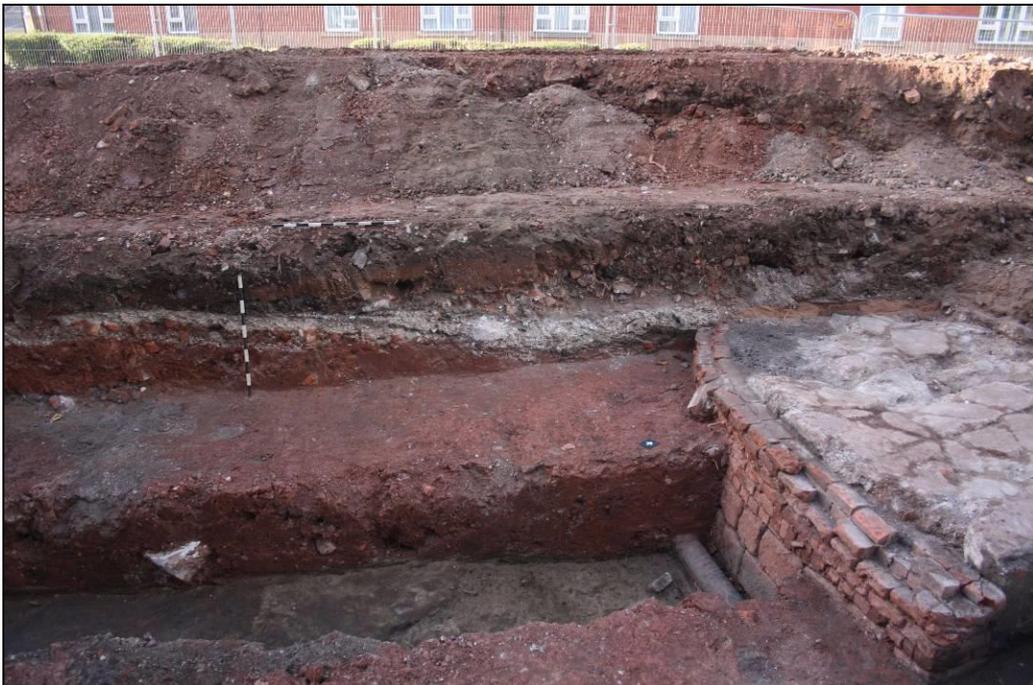
Figure 3. East facing section of Trench 801 showing location of concrete and 33kVA cables

During the excavation of the trench, the construction cut for the southerly oriented 33kVA cables was exposed in the east facing section and appears to have been excavated down to the top of the concrete slab (figure 3). The cut was backfilled with sand and does not appear to have compromised the structural elements of the mill leat. The trench has been signed-off by the Derbyshire Development Control Archaeologist and is expected to be backfilled by the middle of next week.

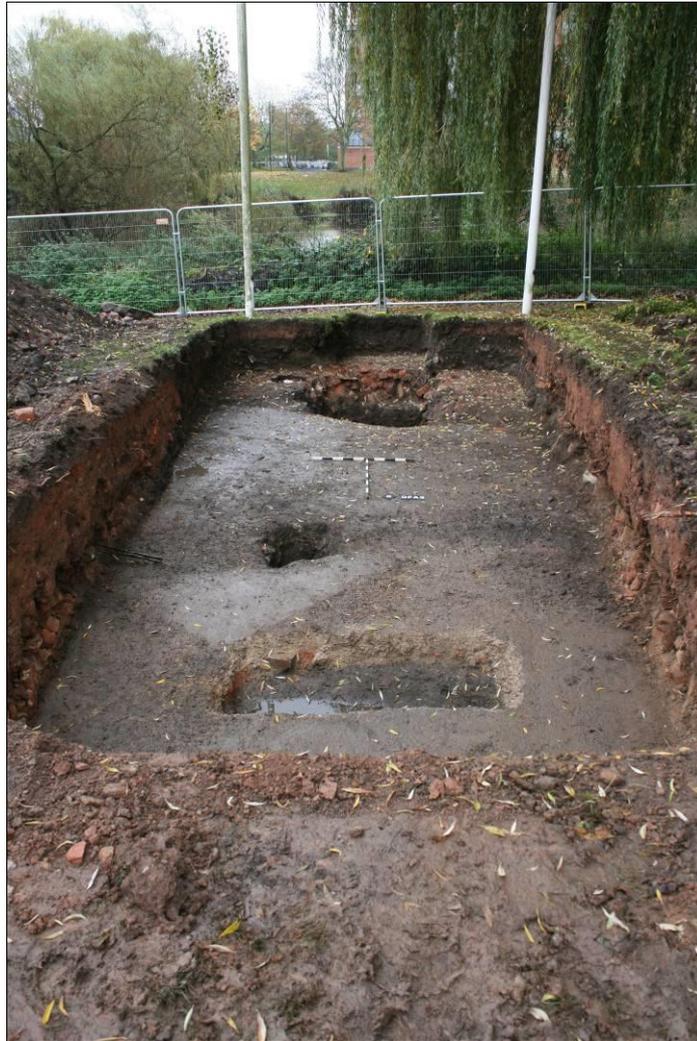
Figure 4. Photograph of Trench 802 looking east

Trench 802 was excavated to 1.2m in depth, stepped in, and excavated to a further 0.5m in accordance with agreed safe working practices (figure 4). The 1.7m maximum depth reached by the excavation appropriately evaluated the archaeological features and deposits which may be compromised by future ground reductions sited between the Silk Mill, Sowter Road, the River Derwent and Causey Bridge.

The ceramic building material partially sealed a concrete slab and a black clayey silt approximately 1.1m below the modern ground surface in the western part of the trench (figure 4). The concrete formed a relatively flat surface at 46.716m. The concrete slab observed in Trench 801 is likely to have served the same purpose and may have been deposited at the same time. The black clay silt continues beneath the concrete slab as evidenced by two additional test pits excavated within the trench towards the eastern and western limits of the trench (figure 7).

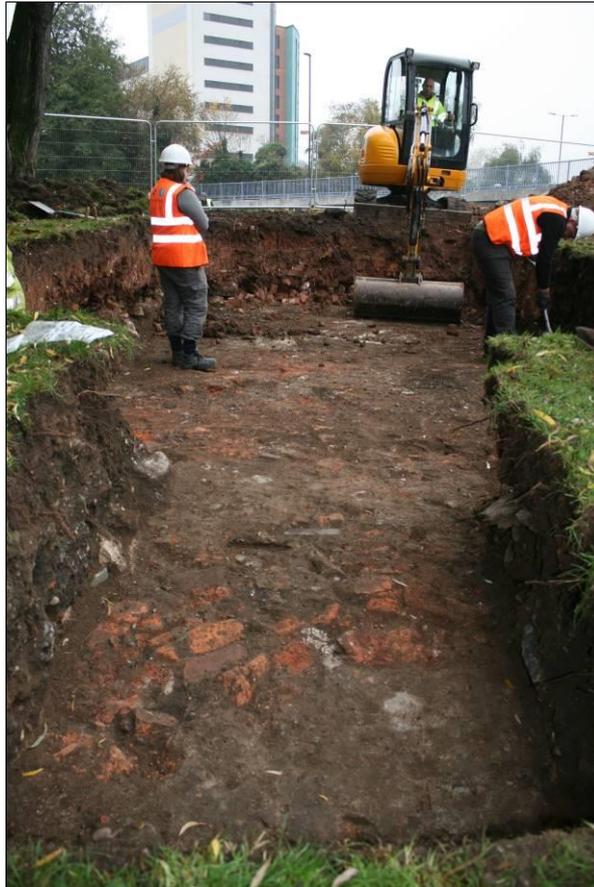
Figure 5. Compacted ceramic building materials

The eastern extent of the trench exhibited a very compacted conglomeration of brick, tile and other ceramic building materials (figures 5 and 6). An absence of early modern/post medieval pottery or general Victoriana suggests that its deposition is likely to have occurred in the last 50 years.

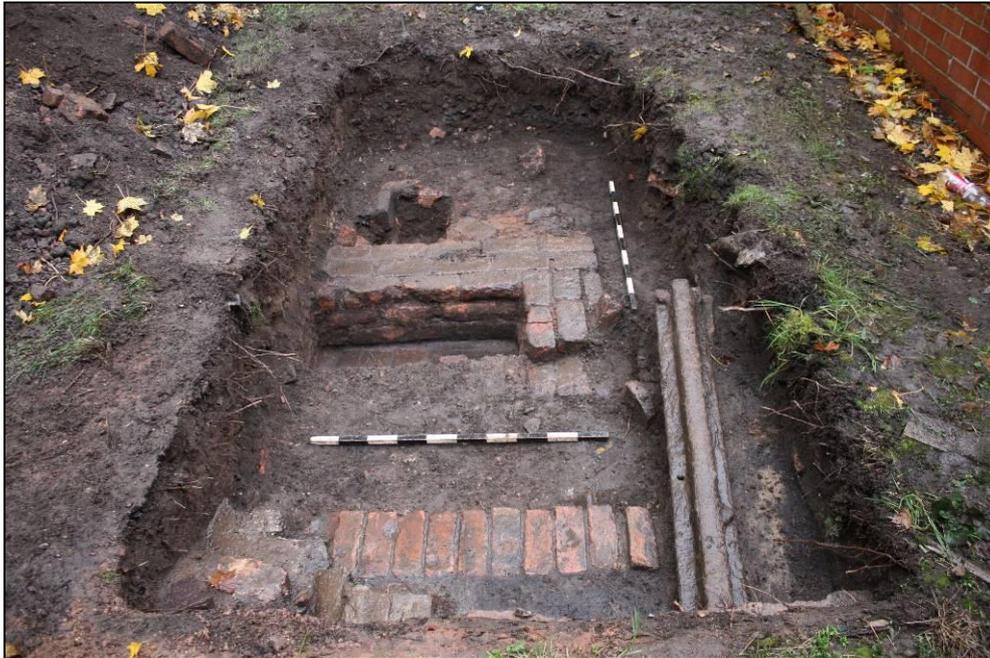
Figure 8. Photograph of Trench 701 looking north

The targeted remains in Trench 701 were identified 310mm below the modern ground surface (figure 6). As predicted, the easterly oriented wall which exists on the 1884 OS map is located laterally within the centre of the trench (figure 8). The area within the trench to the north of the wall was occupied with a floor surface, indicating that it may represent the interior of the Britannia Foundry and Engineering Works (figure 9). The space to the south of the wall is likely to have been a coal wharf. Numerous engineering activities over the last century have disturbed the *in-situ* remains.

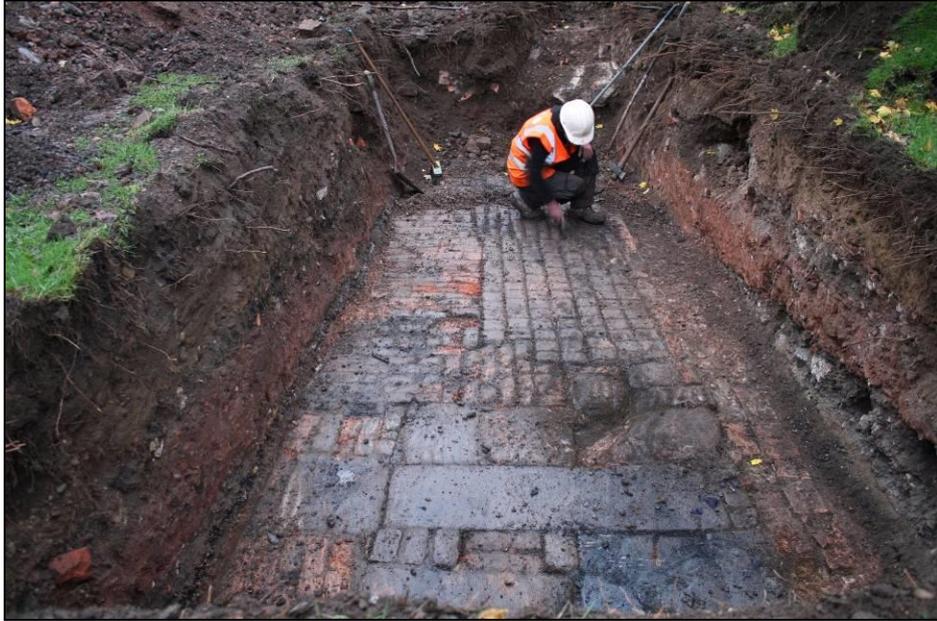
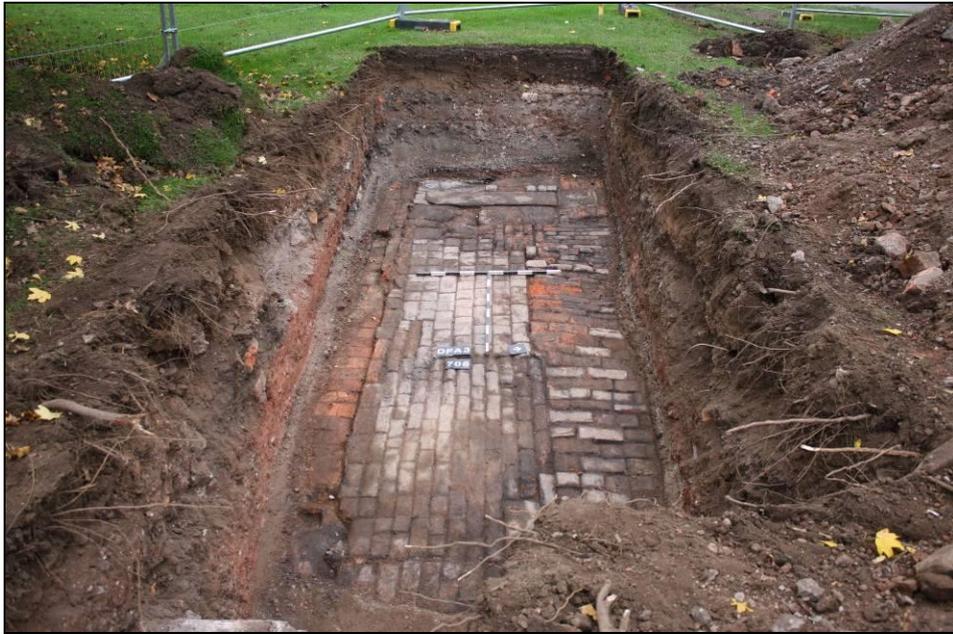
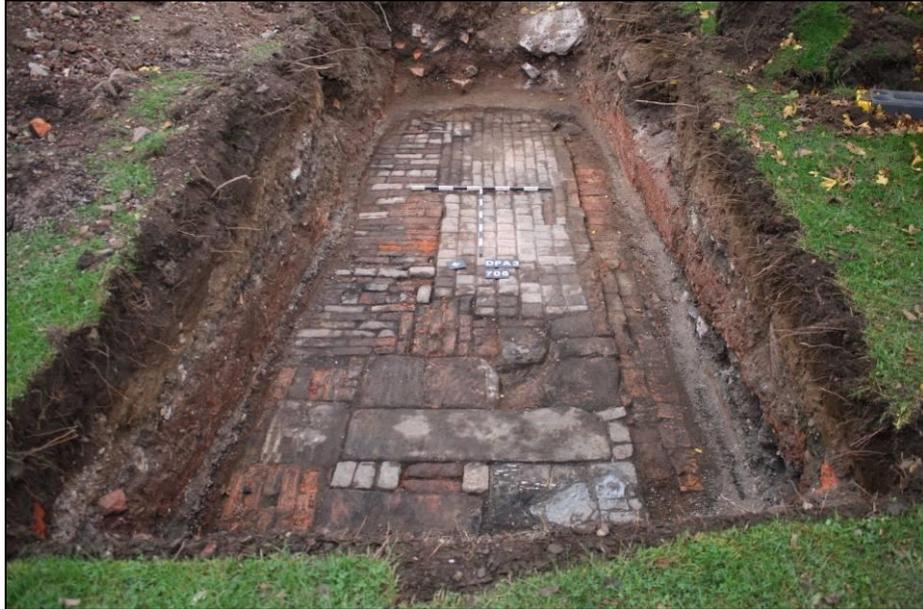
A brick surface was revealed 1.1m below the modern ground surface in Trench 706 (figure 10, 11 and 12). The historic mapping indicated that a north-easterly aligned wall would be revealed centrally in the trench which could be used to infer if the structural remains demarcated internal or external space. As it happens, the trench appears to have been sited within the interior of the walled enclosure, visible on the 1884 mapping. Although no evidence was provided within trench 706 for what may exist beyond the perimeter of the wall, evidence provided by Trench 704 tentatively suggests this was external space or perhaps used as an area to deposit demolished building material on.

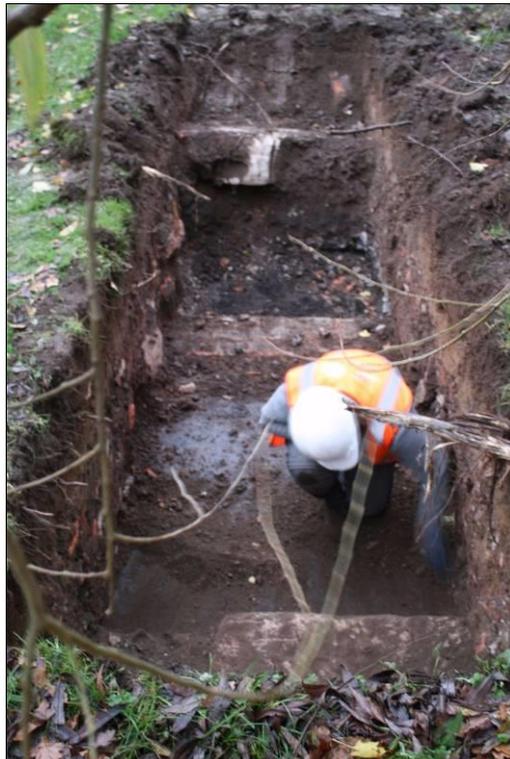
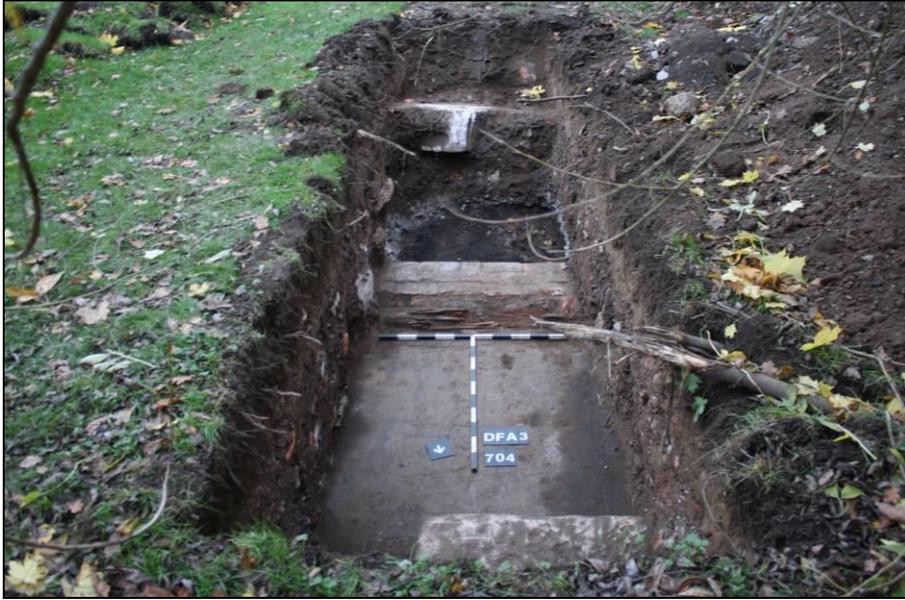
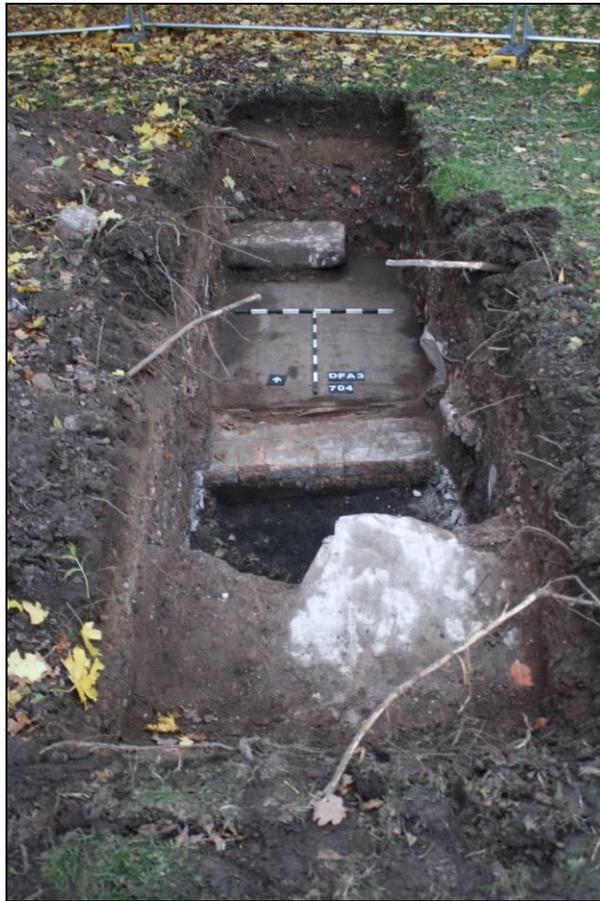
An easterly aligned wall, as indicated by the 1884 mapping, was revealed in Trench 704. The brick structure was three courses thick and was identified 1.1m below the modern ground surface. Abutting the northern face of the wall was a weathered tarmac surface. Material to the south of the wall was loose mixed material which may represent demolition material or a lightly compacted external area (figures 13, 14 and 15).

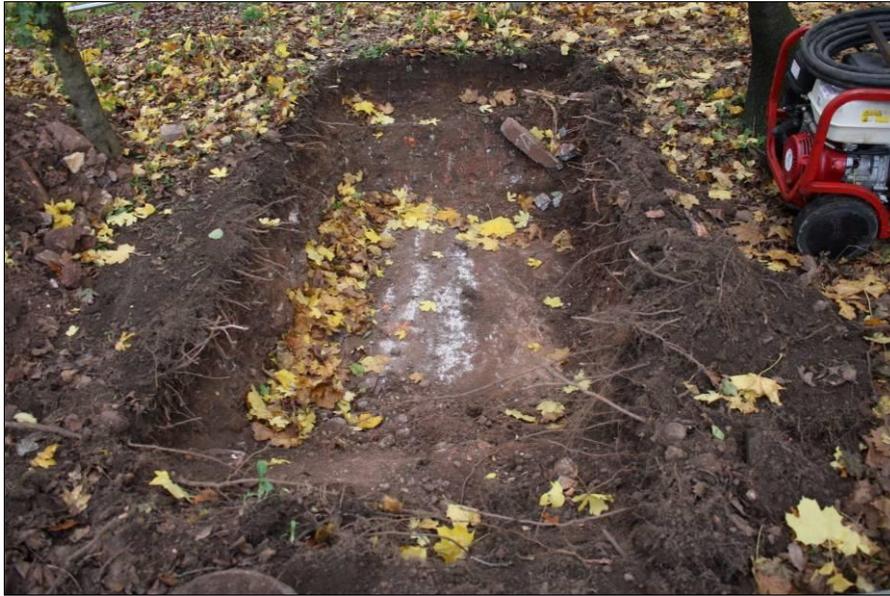
Figure 16. Photograph of partially excavated Trench 705

Progress was hindered by the identification of a concrete slab which required removal with a portable pneumatic drill (figure 16). Once the concrete slab was removed a depositional sequence very similar to that observed in Trench 704 was revealed. The targeted wall was revealed crossing the trench laterally and was of a construction style similar to the one identified in 704. The space to then north of the wall was occupied by a

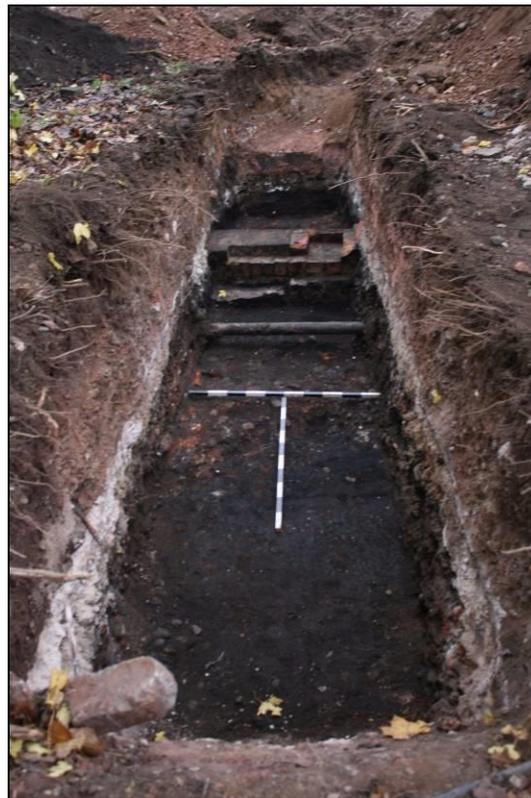
Figure 17. Photograph of Trench 705 looking south-east

layer of degraded tarmac whilst the southern side contained loosely compacted material which may have derived from demolition events (figure 17).

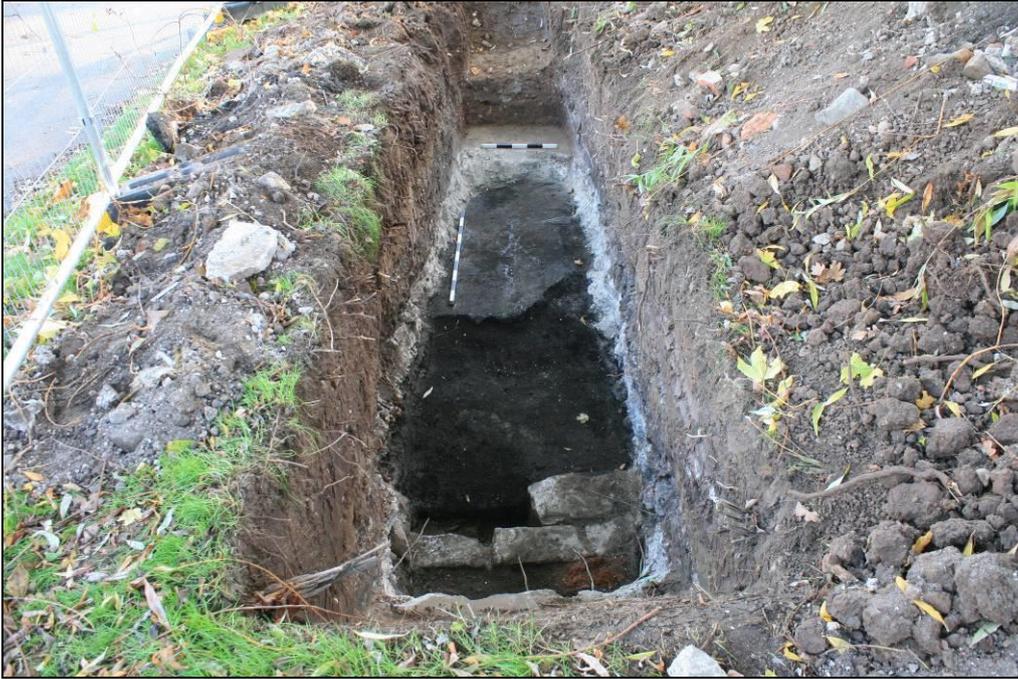
Figure 18. Trench 707 looking south

The excavation of Trench 707 was not intended to target any specific feature on the historic mapping. Based on evidence from the excavation of the other trenches in AMA 7, its situation suggests that the trench may locate floor surfaces associated with the Britannia Foundry and Engineering Works. As anticipated, a floor surface was revealed. It extended across the entire trench and was identified 1.15m below the modern ground surface. The composition of the floor surface was regarded as being very similar to the surface located in the northern half of Trench 704 (figure 18). This may in fact represent the same structure.

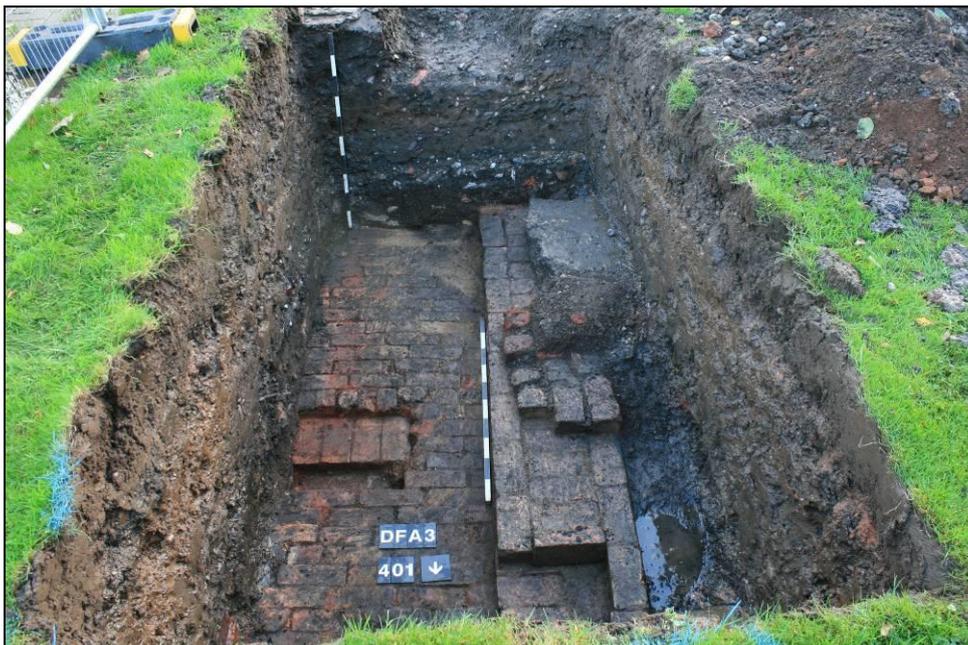
Figure 19. Photograph of Trench 401 looking south

The excavation of Trench 401 was expected to reveal the structural remains from the former Union Iron Foundry. According to the 1st edition OS mapping, the footprint of the evaluation trench crosses an easterly oriented foundation from the now demolished works. The results from the trench actually revealed a northerly oriented brick wall suggesting that the foundry, or subsequent building, has been remodelled since the 1880s which has destroyed any evidence of the earlier building (figure 19). This trench is completed and awaiting inspection from the Derbyshire Development Control Archaeologist.

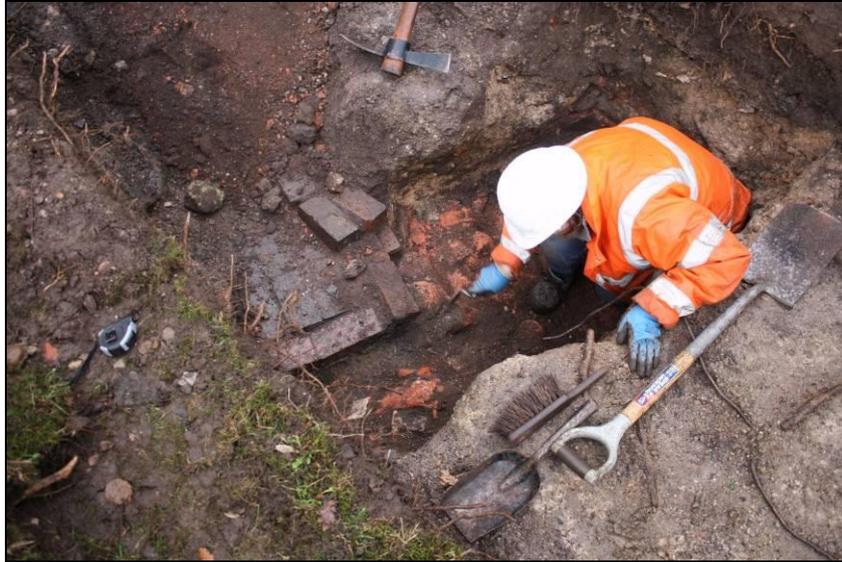
The excavation of Trench 402 revealed a thick layer of concrete (figure 20). This required excavation with a machine mounted hydraulic breaker due to the depth of the concrete. A series of iron anchor bolts were revealed within the concrete indicating that the material has been deposited to support heavy lifting machinery such as a crane. The absence of concrete in this style of construction in other trenches suggest that it only exists in a location local to Trench 402 which supports this suggestion that this acted as a temporary base.

Figure 20. Excavation of Trench 402. Concrete to the right and upper part of the photograph.

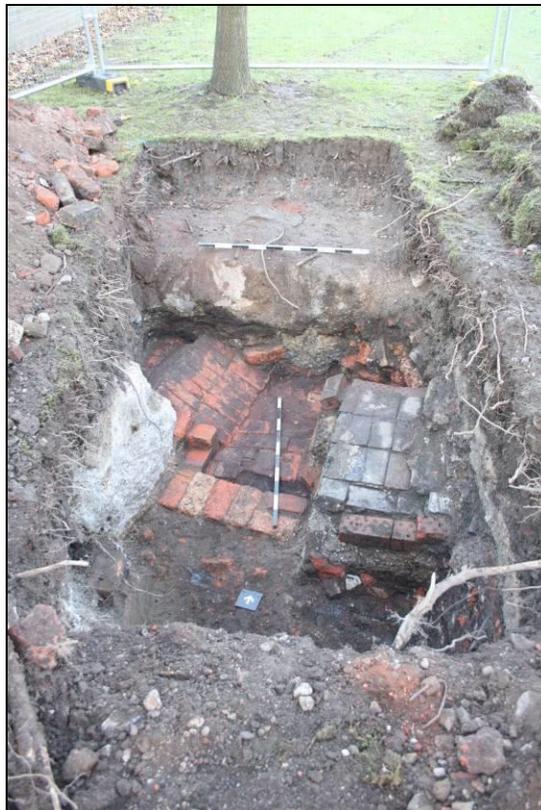
Figure 21. Photograph of Trench 402 looking north

Surprisingly, archaeological remains were found to exist beneath the concrete base (figure 20 and 21). Multiple phases of building were identified, the earliest of which appears to have acted as an industrial feature such as a flue. Later additions to the building including a floor indicate that the building was redeveloped at some stage prior to the buildings abandonment and demolition.

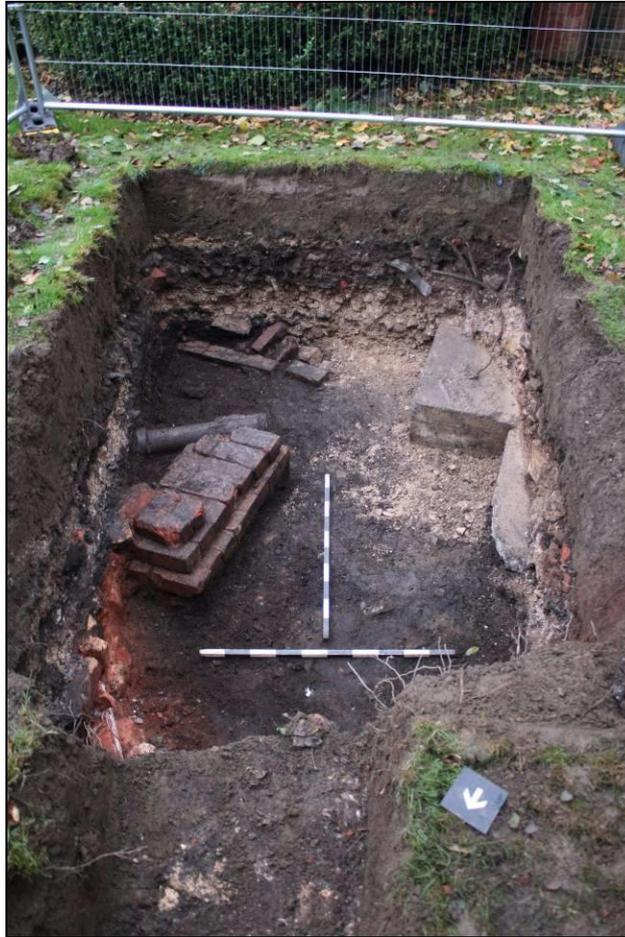
Figure 22. Photograph of Trench 403 looking south

The exact location of Trench 403 was not tenable on account of the presence of plants and shrubs which were planted by the current residents of Etruria Gardens. As a consequence, the trench was moved 2.5m to the north. The repositioning of the trench still successfully identified the northerly oriented brick wall of the Sun Foundry which was targeted by the trench (figure 22). The remains of the wall were partial. Later features such as the installation of drains and a possible wall or industrial feature had badly damaged it. The wall/industrial feature was identified in the north-eastern corner of the trench and can be characterised as a formation of bricks within a broad cut backfilled by crushed brick or heat affected clay.

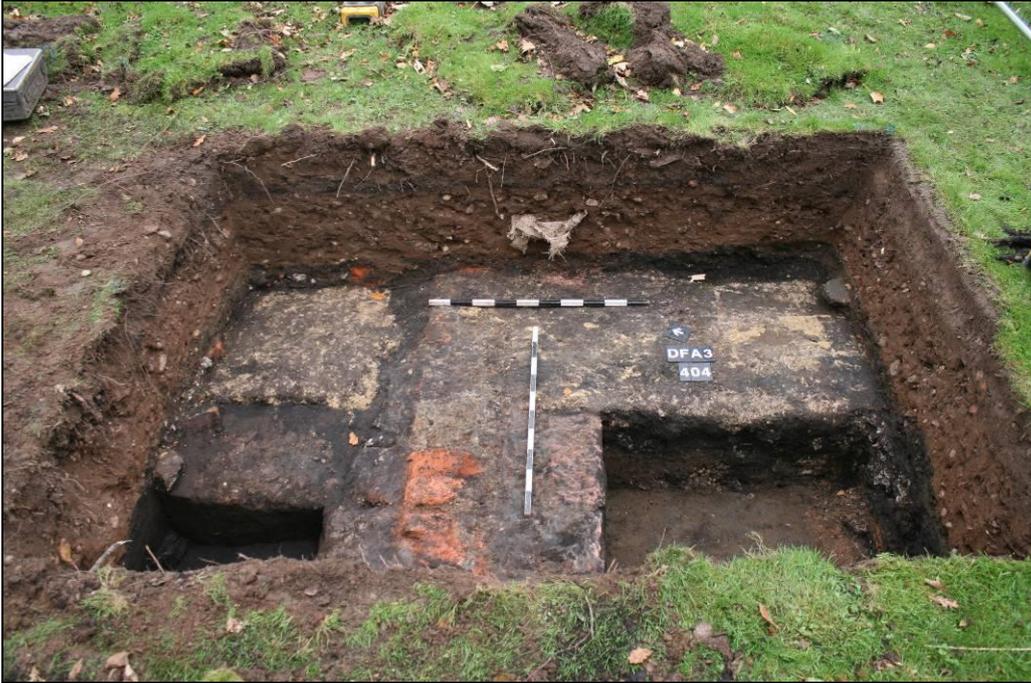
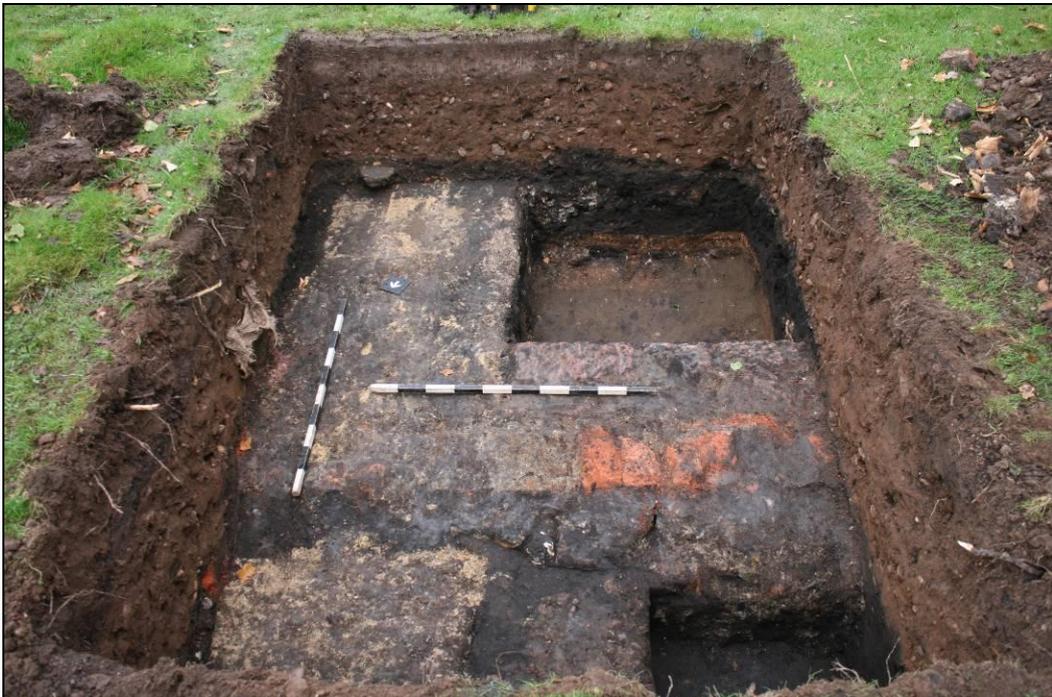
Trench 404 was targeting a large north-easterly oriented brick wall which is present on the 1884 historic mapping. The wall was identified 300mm below the modern ground surface. In addition to the brick wall were concrete slabs which respected the wall and appear to be either contemporary with the brick structure, or acted as a later improvement to the building (figures 23 and 24). Unfortunately, no stratigraphic relationship could be observed with which to determine a sequence of events although it seems likely that the concrete slab may have been a later addition.
